30th Conference of Experimental Stress Analysis  
30. konference o experimentální analýze napětí  
2. - 5. 6. 1992 ČVUT Praha Czechoslovakia

STRAIN FIELD MEASUREMENT ON CYLINDER LINERS OF ENGINE BY  
HOLOGRAPHIC INTERFEROMETRY.

Brožman D., Kubík L.

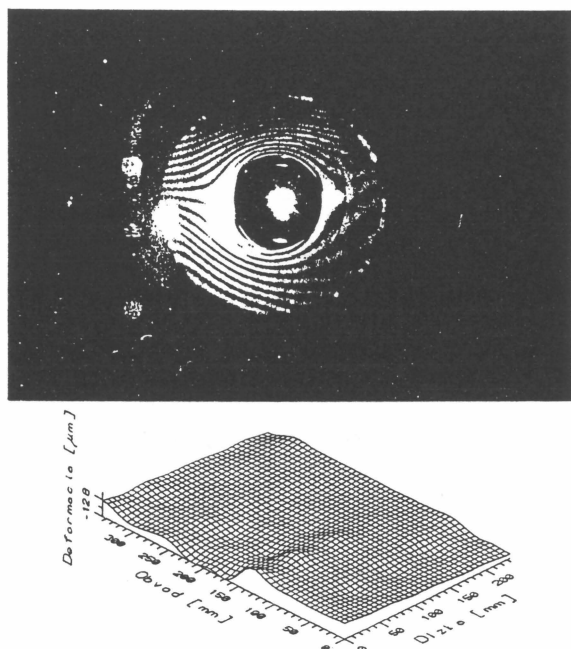
As it is shown in figs.4-6, border cylinder liners are more strained than a central cylinder liner. These deformations are caused probably by inaccurate boring of border engine cylinder, which are emerged after assembly of an engine.

Fig.5 Holographic interferogram and the unfolded inside surface of the cylinder liner illustrating strain of the central cylinder after mounting of a cylinder head.
