## TORSION SYSTEM OF CONVERTERS ANALYSED BY FEM FOR FURTHER VERIFICATION OF LIFETIME BY EXPERIMENTAL METHODS

**Abstract:** During demolition of converter's lining are some parts of the converter overloaded. In order to determine these excessive loads by experimental methods, it was necessary to assess by the finite element method the locations of extreme loadings, where were during demolition measured time-dependent charts of stress increments. By localization of such locations for measurement with the FEM was developed the base for application of sensors. Verification of lifetime was realized according to standards for the assessment of lifetime of carrying structures. One of the inputs for the assessment was time-dependent chart of stresses during process of demolition.

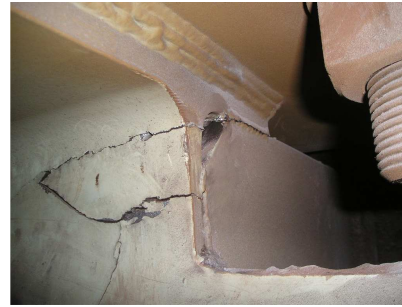
During inspection of the pedestal there were found cracks in the welds between the vertical console, the stiffening rib and the flange of the pedestal's I-beam on the side of the tapping as well as in the I-beam's web (Fig.4).

**Figure 4:** Cracks in the pedestal of the converter's torsion system in the location of the weld between the vertical console and the flange as well as in the I-beam's web.

In order to ensure further safe operation of the converter the following measures were undertaken by the operator at the recommendation of the producer:

- cracked weld between the vertical console and the flange of the I-beam was repaired,
- in the location of fractures in the I-beam's web two steel plates were welded from both sides by a fillet weld along the whole perimeter (Fig.5a).
- for the reinforcement of short welds between the vertical console (which connects the pedestal with the converter stand) and the flange of the I-beam two horizontal steel plates were welded on both sides (Fig.5b),
- in order to provide reinforcement, four sloping stiffeners between the converter pedestal and the lower flange of I-beam were added (Fig.5b).

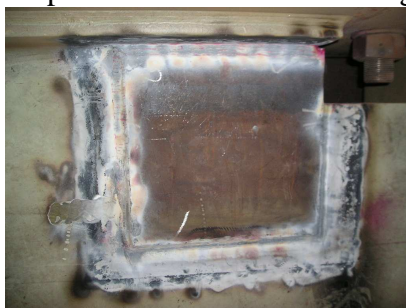
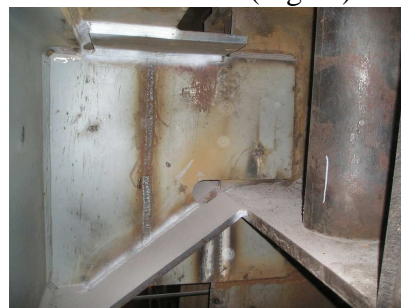
**Figure 5:** Modifications carried out for ensuring further operation of the converter a) plates welded in the locations of cracks in the I-beam's web, b) bracing by horizontal plate and slanted stiffener.

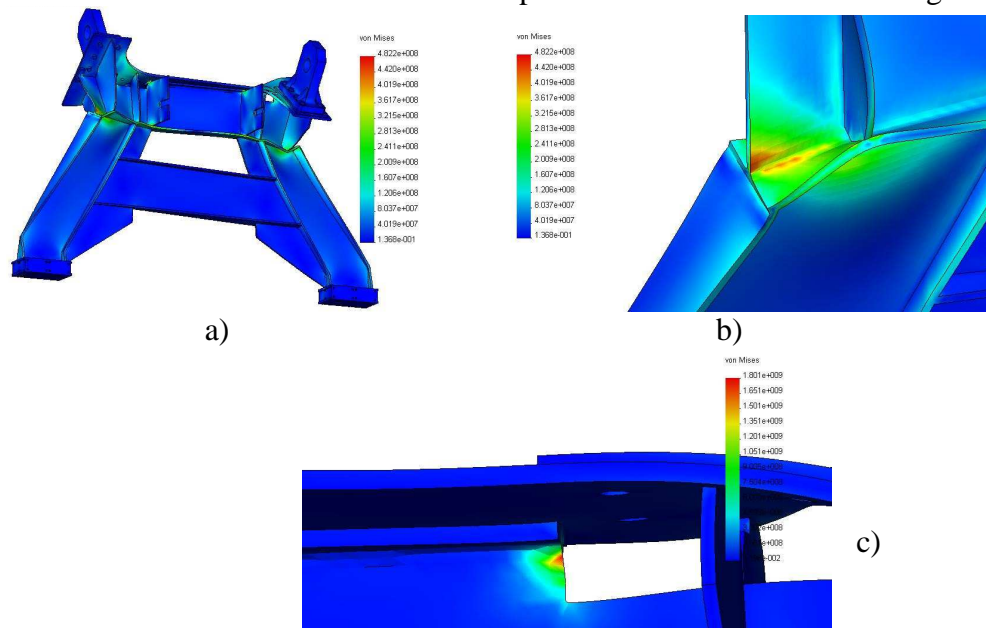
Fig.6a shows the fields of equivalent stresses in the pedestal of the original structure without modifications. From the figure it is obvious that plastic deformations develop in the locations of maximum stresses because the pedestal is made of steel sheets grade S235.

**Figure 6:** a) Equivalent stresses in the original structure of the pedestal for the tilting moment 6322 kNm, b) Location of extreme loading at the end of I-beam' web, c) Location of extreme loading near the weld between the vertical console and the upper flange of I-beam (computation for a model with artificially developed a crack).

The locations of extreme loading appear at the ends of I-beam' web in the area of its joining to the legs of the pedestal (Fig. 6b) and in the location of the weld between the vertical console and the upper flange of I-beam (Fig. 6c), i.e. in the location where a crack was initiated and spread further. In Fig.6c is computation for a model with artificially developed a crack in order to study its influence to web. Further computations carried out on a model with artificially modelled crack in this location showed that secondary cracks initiated in the I-beam' web due to normal stresses developed after failure of the weld between the flange and the vertical console (Fig.4).

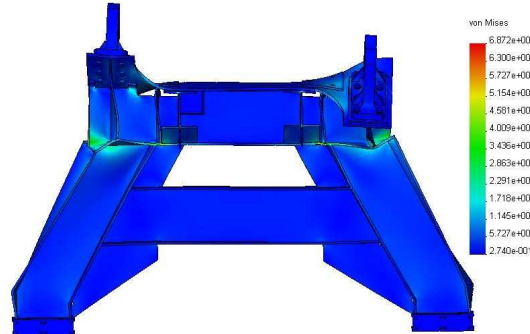
**Figure 8:** Equivalent stresses in the modified pedestal of the torsion system for the tilting moment 6322 kNm.

As Fig.8 shows due to realization of the suggested improvements the stresses were decreased in the locations of cracks, but at the same time the stresses were increased in the location of joining of the pedestal leg and I-beam (Fig.9). The maximum stresses were higher by 43% than maximum stresses before the improvements.

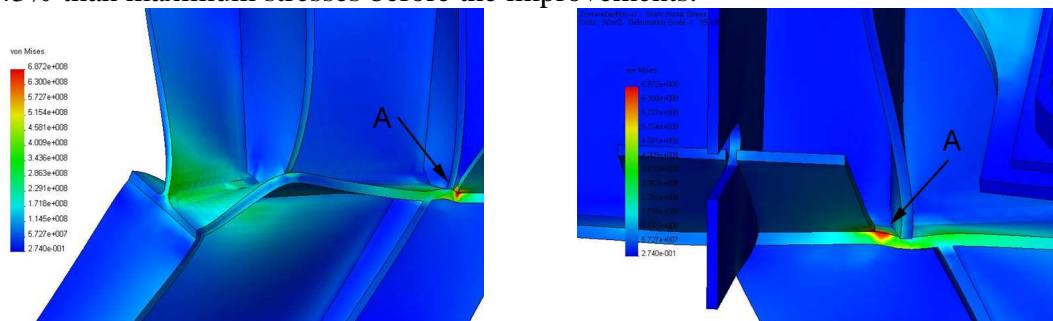
**Figure 9:** Equivalent stresses in the connection of the pedestal leg and I-beam – pedestal after modification (tilting moment 6332 kNm).

In the location of extremal loading were applied resistance strain gages [5] and the measurements have confirmed the levels of stresses determined by numerical analysis. However, it have to be mentioned that due to smaller tilting moments during operation (cca 2000 kNm) were the extremal stresses adequately smaller. In spite of warnings that there can arise cracks in torsion system during further operation, the producer allowed the operation with converters with the pedestals modified according to previous description.

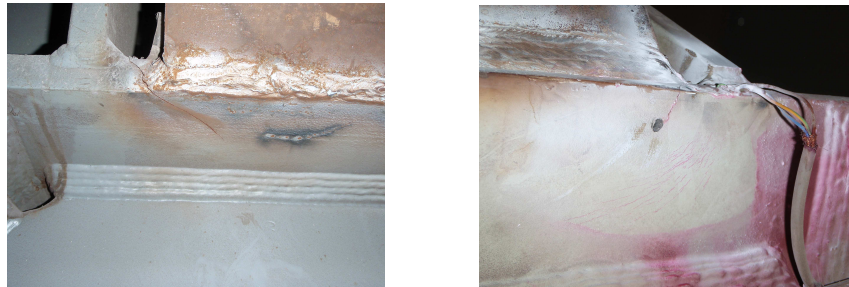
After visual inspection of the pedestal of the converter's torsion system before application of strain gages it was found out that there were significant cracks in locations of extreme stresses, which were identified by finite element computations in the previous stage of solution (location A, Fig. 9). The cracks occurred in the pedestals of the torsion system of both converters in the bottom flange of I-beam, always on the inner side of the stand on the side of the converter pedestal (Fig. 10).

The length of cracks reached 120 mm and the inclination of cracks to the surface was invoked by high shear stresses. As it was necessary to finish demolition of the converter lining, holes with diameter 6 mm were drilled in the crack tips to prevent further crack growth.

**Figure 10:** Cracks on the bottom flange of I-beam in locations identified by the finite element computations (location A, Fig. 10).
