Failure analysis of the moving knife holder of a shredding machine

Abstract: The paper focuses on the analysis of the causes that led to knife holder failure. The holder is a part of the car tyre shredding equipment. Based on the evaluation of the operating conditions of the machine, examination of the condition of the knife holder after the failure, analysis of the fractured surface as well as the material properties of the examined structural elements, it was possible to draw conclusions as to the reasons for the failure.

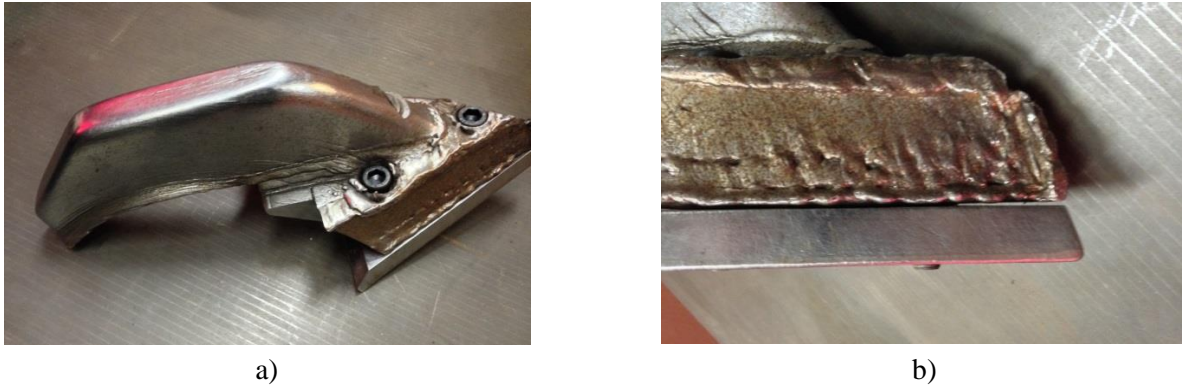
Fig. 6: Knife holder with a moving knife- fixed by three bolts a) top view, b) side view.

- The failure could also occur because of the increased mechanical stress of the welds of the holder of the moving knife as it was not supported by the holder along its whole length (Fig.6b).

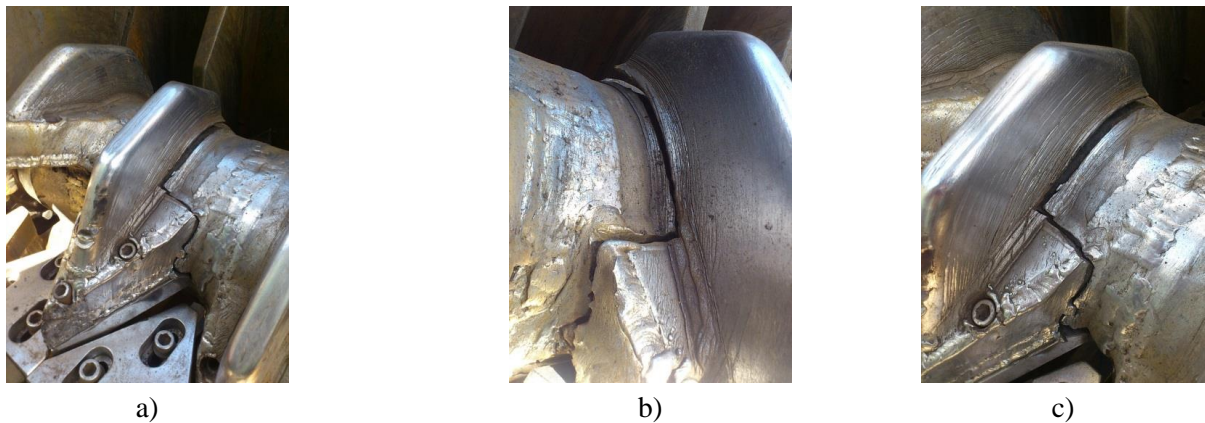
Fig. 7: Failure of the welded joint of the moving knife holder a) general view , b), c) detailed view of the failed welded joint.

The failed weld of the moving knife holder is shown in Fig.7a. The details of the failed weld joint of the holder are given in Fig. 7b; c. Fig.8 shows the fracture surface of the holder with the moving knife of the shredding machine, Fig.9 gives a view of the fracture surface on the rotor shaft of the shredder.

- Microstructure was built by ferritic-carbide mixture with polyhedric grains and local linelike arrangement of the carbide particles.
- The analysed part of the machine failed due to the repetitive mechanical stress. Fatigue failure initiated at a point of a defective, poor quality weld and stress concentration ,

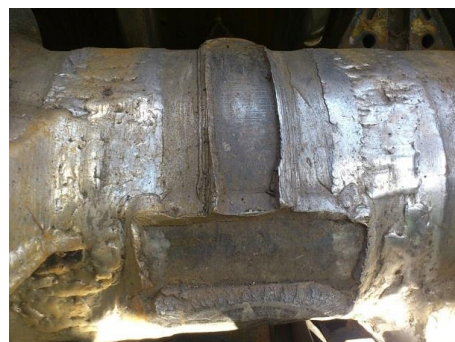
Fig. 9: Fractured surface on the shaft of the rotor

From Fig. 9 it is obvious that the fracture occurred in the location of the weld due to cyclic loading during the tyre shredding process. Samples were taken from the location of the fractured surface of the knife holder in order to determine chemical composition and hardness as well as to perform metallographic analysis with the aim to identify material quality and assess its welding property (Fig.10a, b). In the samples, subsurface cracks were found in the locations of the welds (Fig.10c).

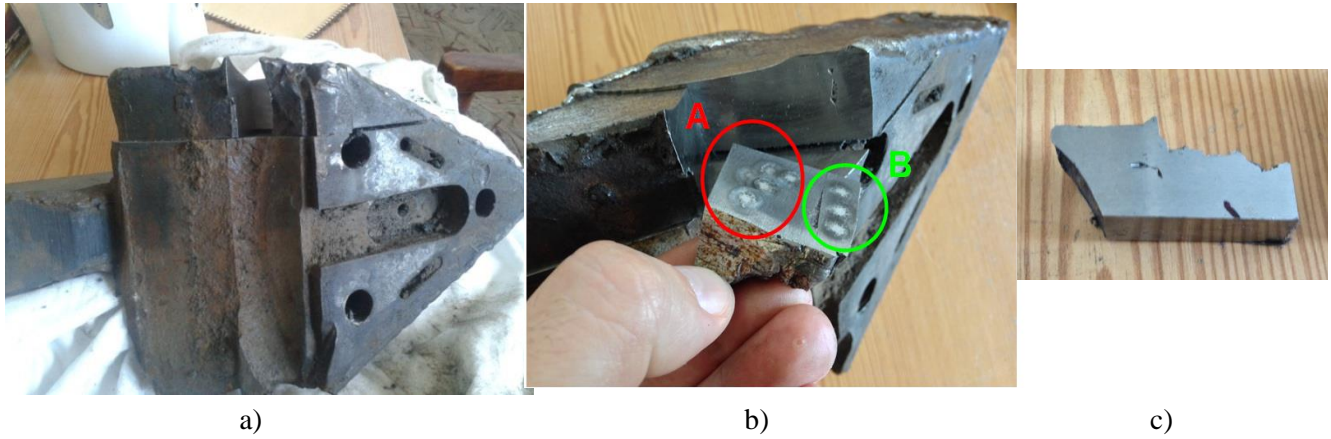
Fig. 10: a, b) Locations where samples were taken and analysed, c) subsurface cracks in the samples a, b)

Chemical composition was determined by spectrometric analysis in two areas: A and B (Fig. 10b) since two different materials were used there. To adjust the moving knives, steel plates were welded to the holders to support the knives. Table 1 and Table 2 contain average values of the chemical composition obtained by measurement and chemical composition of these materials determined on the basis of the data as given in [4].

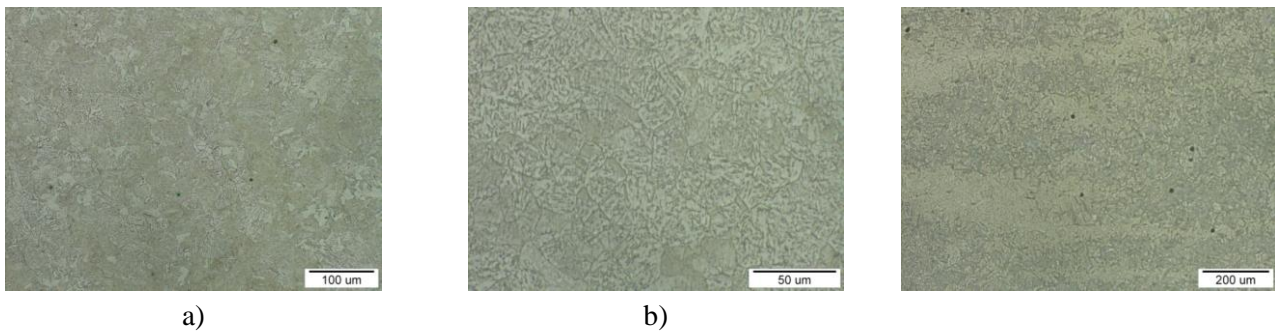
Fig. 12: a), b), c) microstructure of the material at various scales

Microstructure was built by ferritic-carbide mixture with polyhedral grains and local linelike arrangement of the carbide particles.
