Analysis of stress states in critical parts of supporting structure of steam boiler and determination of its residual life span

Key words: Supporting structure, Strain gage measurement, Residual lifespan

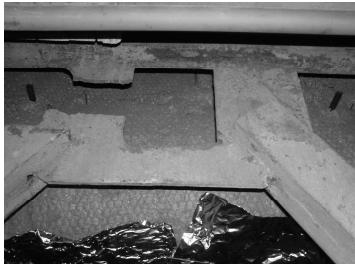
Fig. 2. Burned-out of framework joint sheet.

In Fig. 2 is shown sheet of framework joint of brace strut in the high level 3.3 m on the left side. During the inspection was found out that from the sheet of the framework joint was burned-out middle part with interruption to outer profile. From the Fig. 3 is obvious that the webs of closed beam are not planar that can invoke increased levels of loadings and problems with stability.

- modifications of truss in high level 3.3 m that are in drawings were not realized and despite of fact that the design is not perfect, the authors tip off that this part of supporting structure have to be solved.
