## Non-destructive analysis of concrete from Northwest Bohemia defence structure built in 1937

**Description of the analysed bunker.** The defence structure analysed in this contribution is the type no. 37 with full designation C27/52a/A-140Z, see the photography on Fig. 1. "C27" means the line section of the defence system in Czechoslovakia, in this case Lišany, while "52a" is the number of bunker in line. The letter "A" means the type of bunker when this is the most widespread type of light defence structure. And the number "140" indicates the angle of shots in degrees (the used degree of shots varies between 120° and 220°) [2]. This type was

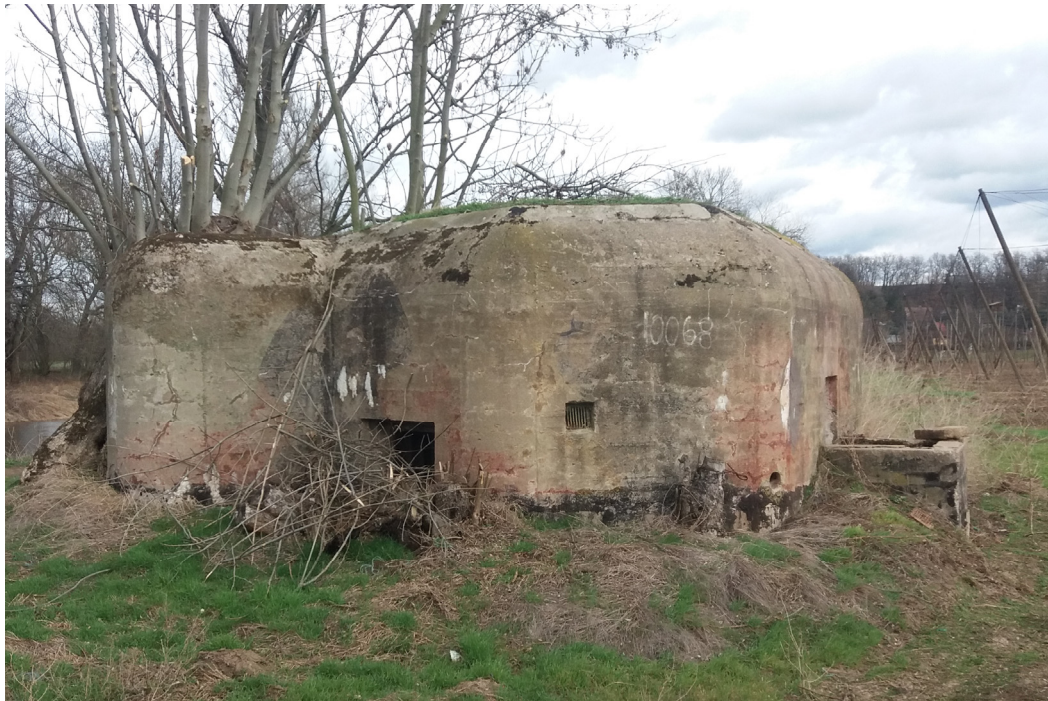
Fig. 1: Photography of analysed bunker no 37 (C27/52a/A-140Z).

The front part, exposed to expected enemy’s attack, was protected by hand-placed rubble that also worked as camouflage. The rest of this wall can be seen on the left side of bunker on Fig. 1 and it is situated in a place of a growing tree.

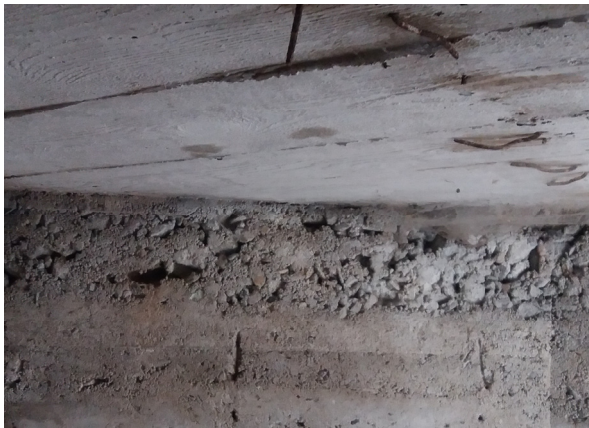
Fig. 3: Different quality of concrete.

The properties of concrete achieve different characteristics while investigated in various locations – for example the denser concrete can be find in the lower part of walls (see Fig. 3). Therefore the measurement took place on three locations – in the top of the wall, in the centre and in the contact with the floor. Totally 45 measurements were performed on each interior locations. From horizontal structures the quality of roof from interior part was also investigated – totally over 50 measurements were performed. The exterior part has specific issue that limits using of Schmidt hammer. After the casting and un moulding of formwork a slim layers of coloured plaster were additionally applied on the massive reinforced concrete structure. These plasters worked as a camouflage shield and in large number of bunkers have been preserved. In investigated bunker, remains of original plasters were identified in the contact of walls and earth (see Fig. 4). From this reason it is not possible to performed non-destructive testing by Schmidt’s hammer without removing original plasters. From this reason only one place from exterior side was analysed (marked as “E” on Fig. 1) where the original plasters has not preserved.

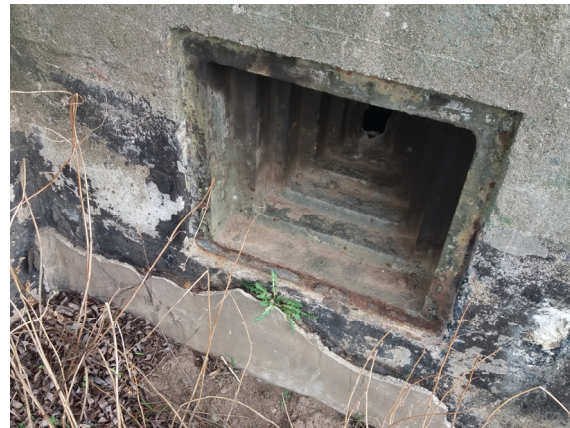
Fig. 4: Remains of the original plaster.
