## TORSION SYSTEM OF CONVERTERS ANALYSED BY FEM FOR FURTHER VERIFICATION OF LIFETIME BY EXPERIMENTAL METHODS

**Abstract:** During demolition of converter's lining are some parts of the converter overloaded. In order to determine these excessive loads by experimental methods, it was necessary to assess by the finite element method the locations of extreme loadings, where were during demolition measured time-dependent charts of stress increments. By localization of such locations for measurement with the FEM was developed the base for application of sensors. Verification of lifetime was realized according to standards for the assessment of lifetime of carrying structures. One of the inputs for the assessment was time-dependent chart of stresses during process of demolition.

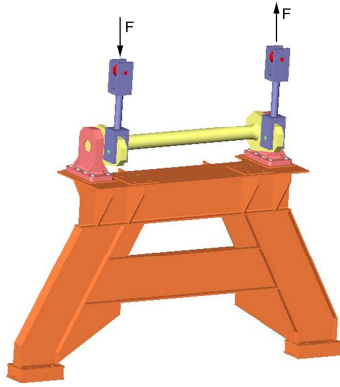
**Figure 3:** Loading of torsion system of the converter.

During operation of the converter the torsion system carries primary loading from tilting moments of the main gearbox of the converter drive and also secondary loading caused by vibration of the steel liquid during the fining process in the converter vessel. This loading (in Fig.3 represented by forces  $F$ ) is transmitted by connecting rods from the gearbox to the torsion shaft and by vertical consoles (bearing house) to the pedestal (Fig.3).

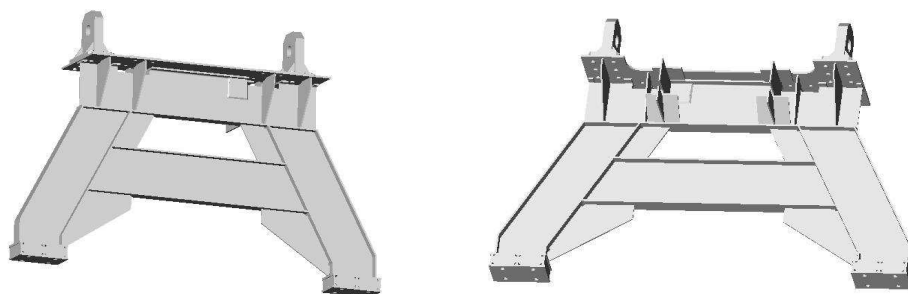
**Figure 7:** Model of the pedestal after modifications performed according to section 2.

Fig.7 gives a computational model of the pedestal after modifications described in section 2 (lapping of locations with cracks by plates, welding of two horizontal plates between the vertical console and the flange of I-beam as well as welding of four slanted plates between the stand of the converter and the bottom flange of I-beam – see Fig.5).
