Failure analysis of the moving knife holder of a shredding machine

Abstract: The paper focuses on the analysis of the causes that led to knife holder failure. The holder is a part of the car tyre shredding equipment. Based on the evaluation of the operating conditions of the machine, examination of the condition of the knife holder after the failure, analysis of the fractured surface as well as the material properties of the examined structural elements, it was possible to draw conclusions as to the reasons for the failure.

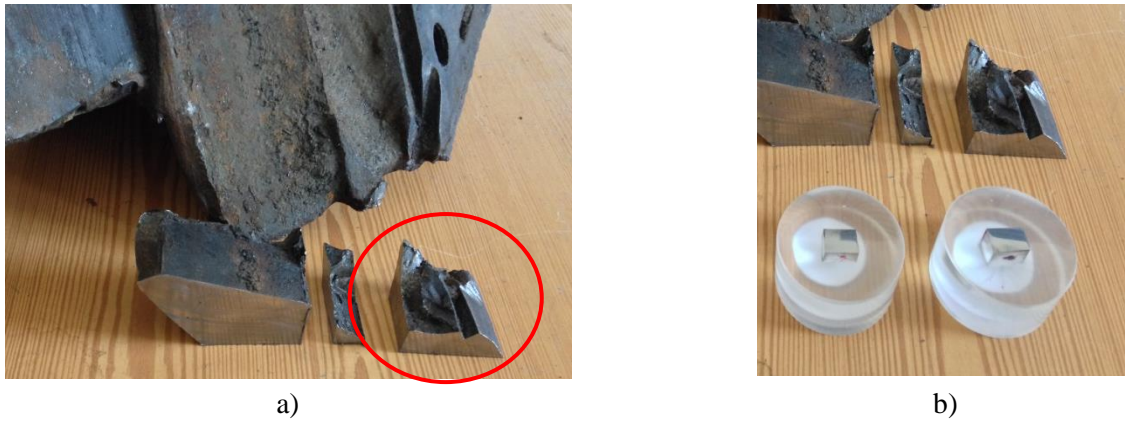
Fig. 11: a) Sample taken for the metallographic analysis, b) cuts in two mutually perpendicular planes

The place on the holder, from where the sample was taken for metallographic documentation, is shown in Fig. 11a. Metallographic analysis was performed in the cross-sections of two mutually perpendicular planes. Fig.11b shows the cuts in these planes.
