Efficiency of Reinforcement Materials on Bus Frame Stability

Abstract: This paper presents the results of an experimental investigation of the CFRP and epoxy foam's effect on bus frame stability. As part of the research, a series of quasi-static tests were conducted to analyze the behavior of the test specimen in four experimental scenarios. Initially, the steel structure was tested, followed by reinforcement with carbon fiber on one post, then extending the carbon fiber reinforcement to both the crossbar and side posts. The final scenario involved filling the steel structure with epoxy foam, excluding carbon fiber. Generally, according to the results obtained, the reinforcing materials have a significant impact on the structural stability of the specimen structure. Namely, the deformation energy in the case of foam and CFRP reinforcement decreased by about 15 %.

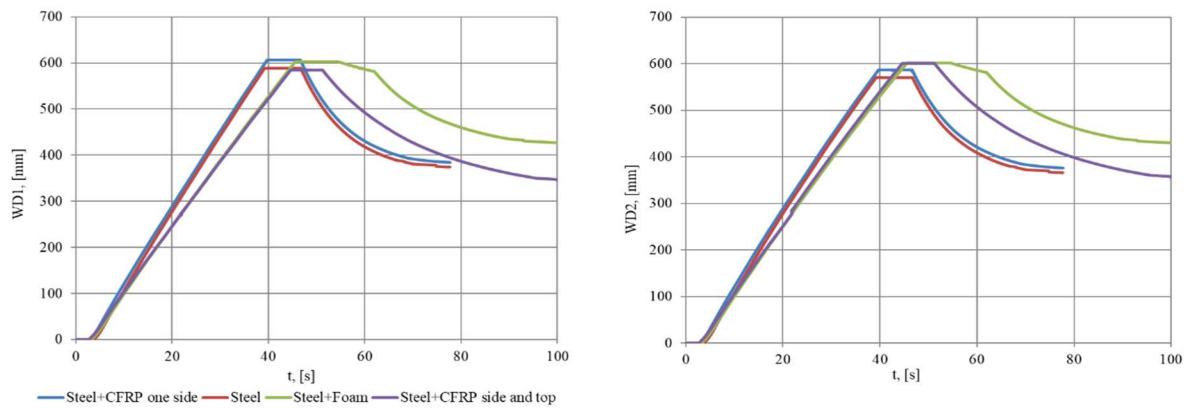
Fig. 7: Specimen displacement across different experimental scenarios. The left and right graphs correspond to the sides of the frame.

As depicted in Fig. 7, the maximum displacement of the specimen construction across all experimental scenarios reached approximately 600 mm. This trend occurs because the applied deforming load of 10 kN exceeds the frame's ability to withstand deformation. Additionally, variations in maximum displacement between experimental cases are explained by tightening or loosening the connection between the hydraulic cylinder and load cell. The plateau observed on the graph indicates the stage of complete compression.

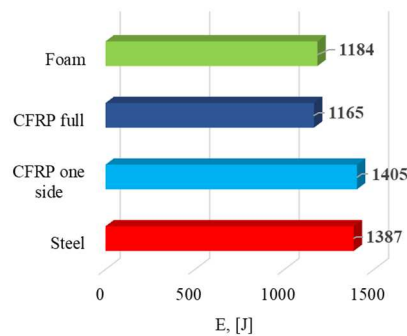
Fig. 9: Elastic deformation energy depending on the bus frame reinforcement type.

Additionally, the elastic deformation energy of the specimen was estimated based on the obtained data, considering the type of reinforcement. Calculation data in Fig. 3 showed that in the cases of epoxy foam and carbon fiber reinforcement on the crossbar and side posts, the deformation energy decreased by approximately 15%. Consequently, under these conditions, the frame requires less energy to maintain its shape under external loads. This achieved due to the higher strength of the structure, which efficiently absorbs and distributes energy during deformation, thus reducing energy losses attributed to elastic processes.

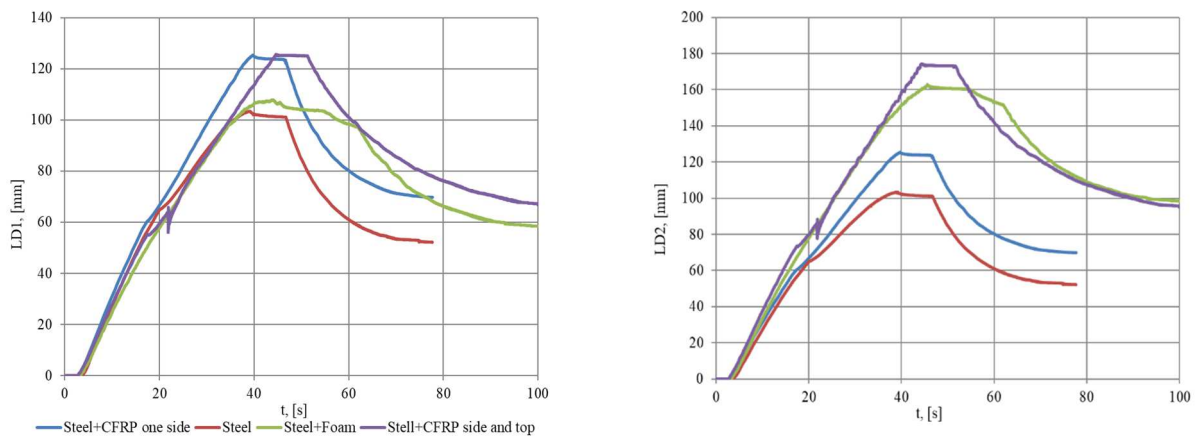
Fig. 10: Specimen displacement across different experimental scenarios.

However, the data in Fig. 10 indicate that the carbon fiber reinforcement case is also characterized by the largest displacement of the structure. This contradiction is explained by the peculiarities of the stress distribution within the specimen construction. In a typical case, for an unreinforced specimen, a substantial portion of the external load energy rapidly converts into plastic deformation of the upper part of the frame. Meanwhile, the residual energy results in only a small displacement of the construction.
